### **Patient Rooms**

**Preliminary results of on going investigation of Sterilray at a VA Medical Center in Ohio.  
For additional information please contact  
John Neister at Healthy Environment Innovations  
email:john.neister@he-innovations.com  
June 23, 2008**

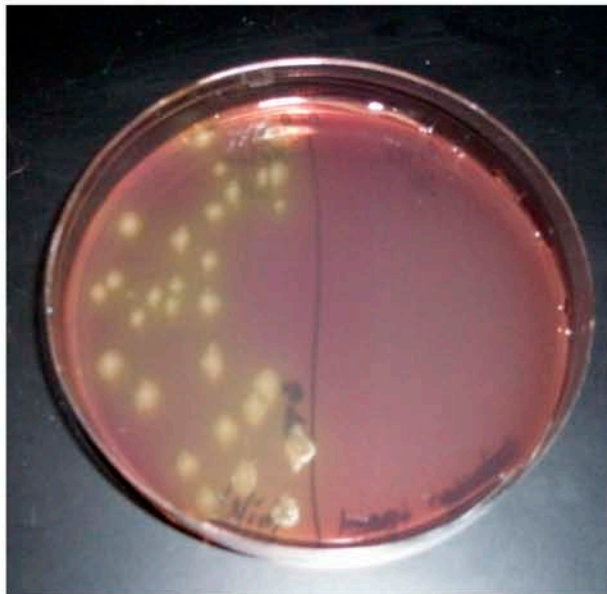
**Sterilray Toilet 122-1 day 1  
Before and After Sterilray**

Below are some photos of examples of cleaning patient rooms with Sterilray. So far, Sterilray reduced C.diff by 96% and 100% of VRE in patient rooms. We cultured small areas, half was swabbed as a before culture and half was swabbed after 5 secs of Sterilray treatment. For example, the call button (6"x3") was split in half and the right side was swabbed before treatment and the left side was swabbed after treatment. The drawback is that we assume a homogenous area of contamination. The probability of always having one side positive and one negative is nearly impossible, so the more rooms we do, the more significant the data becomes.

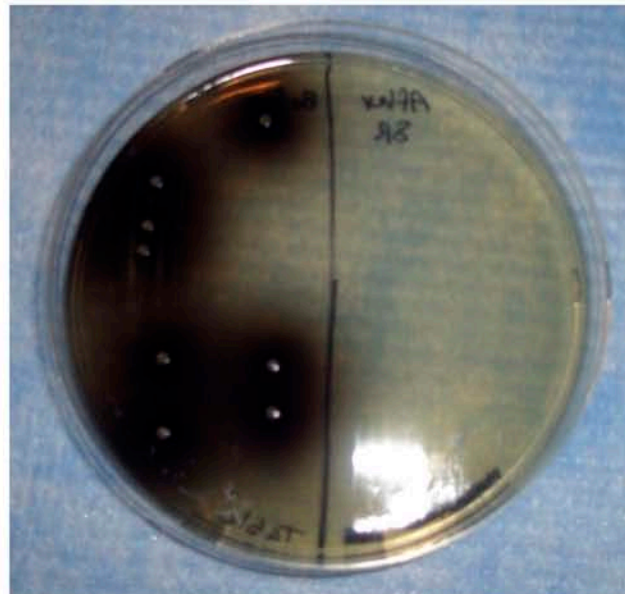
**Sterilray VRE table ex. 2 in room  
Before and After Sterilray**

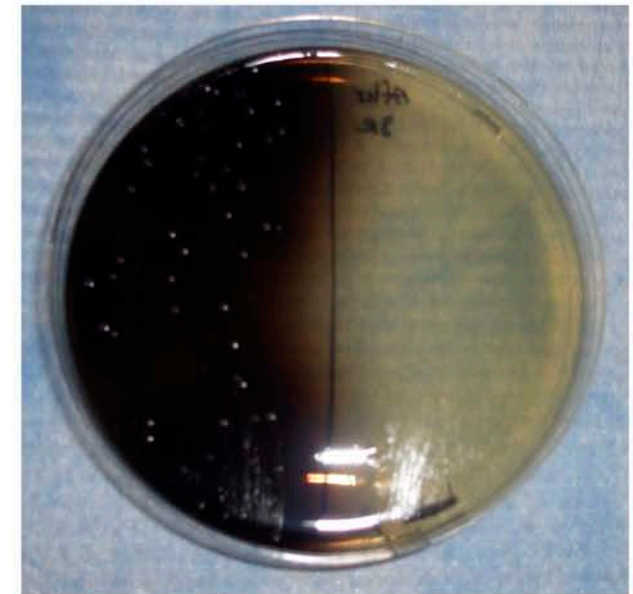
**Sterilray VRE table in room  
Before and After Sterilray**
